# 2004 PROJECT CHANNEL REPORT

INSPECTION OF FLOOD CONTROL PROJECT CHANNELS ON THE SACRAMENTO AND SAN JOAQUIN RIVERS AND THEIR TRIBUTARIES AND THE TRUCKEE RIVER

Prepared By The Flood Operations Branch Flood Project Inspection Section

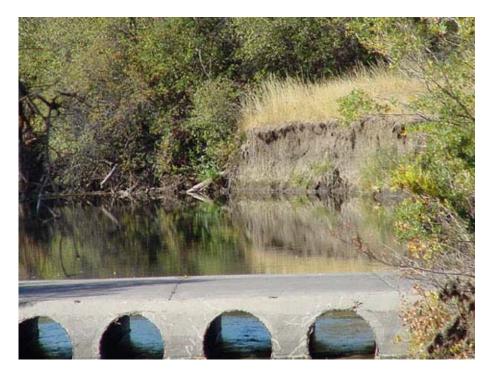
Downstream from Ash street, right bank erosion and tree growth.

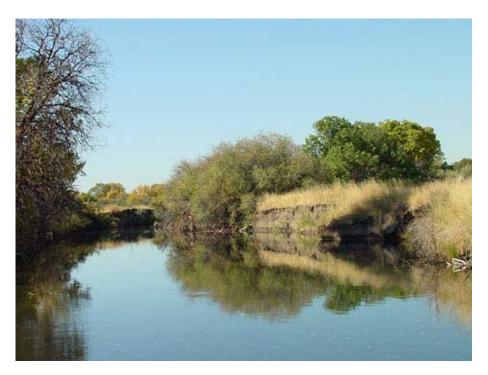
Downstream at a sharp left bend moderate erosion on both banks.

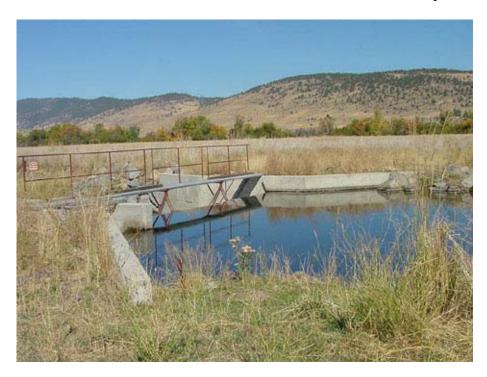
Upstream from the fish ladder and metal walkway. Constructed October 1999 by the Department of Fish and Game.

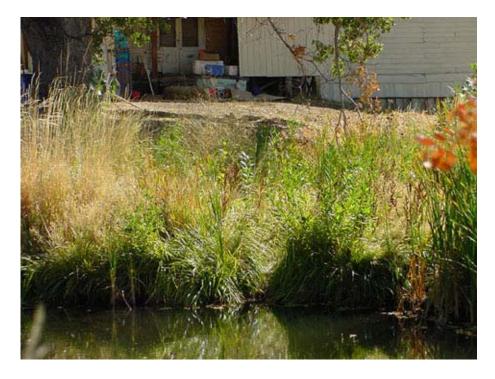
Upstream where Dry Creek meets Ash Creek.

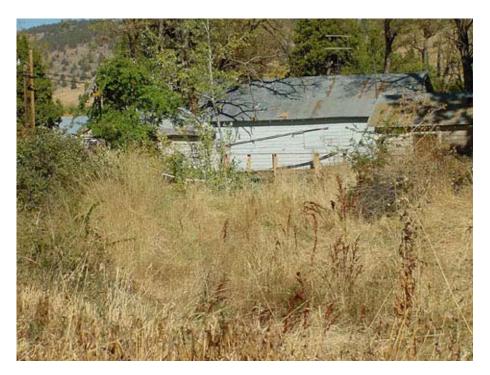
**Downstream at Cedar street.**

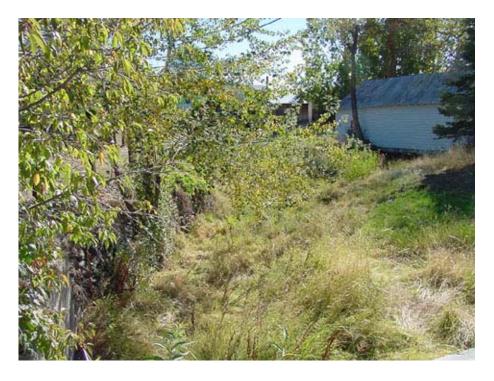
Upstream from Main street (Highway 299), moderate growth in channel.

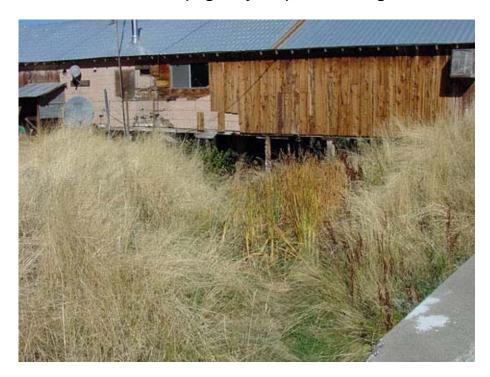
Downstream from Main street (Highway 299), moderate growth in channel.

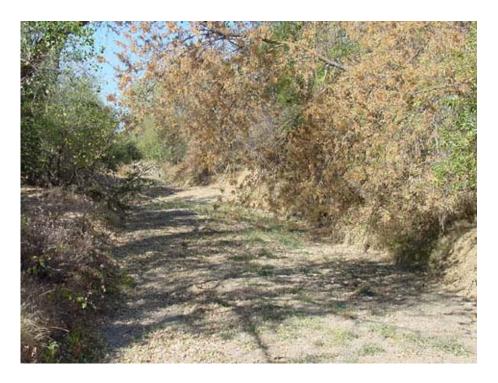
**Upstream at Truckee Avenue.**

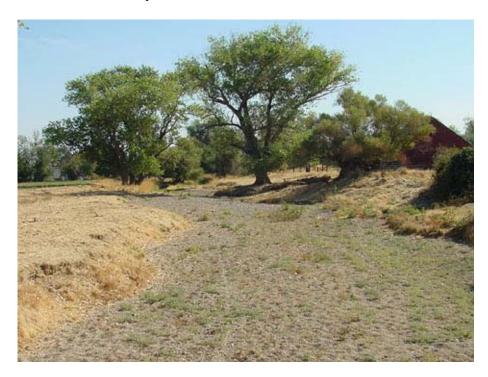
**Downstream from Truckee Avenue.**

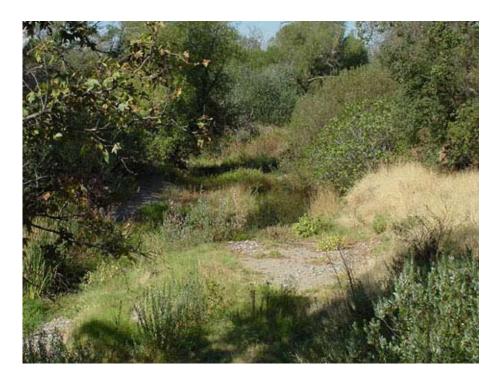
Upstream from old Highway 99 bridge.

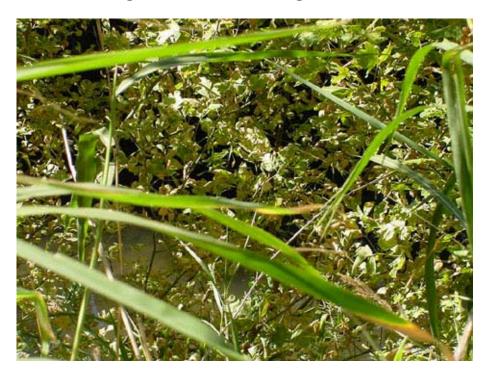
Upstream from the end of Patterson Avenue. Showing the dense vegetation in the channel.

On October 15, 2004, an inspection was made of the Salt Creek channel. The project channel begins 1.6 miles upstream of the Sacramento River and extends downstream 1.6 miles to Salt Creek's confluence with the Sacramento River. Inspection was limited to breaks in the dense vegetation, measured randomly with the vehicle distance meter. The photos on the following pages are typical of, but do not show all of the growth in the channel. Vegetation on both banks is dense and makes visual inspection difficult. Numerous downed trees and piles of debris in the channel should be removed and the channel should be cleared of vegetal growth before the next flood season. A major wash out area is located at end of Salt Creek road. This is being caused by some of the downed trees that should be removed to prevent further erosion. Little or no maintenance has been performed on this channel for the past several years. Tehama County needs to develop a maintenance program for this channel.

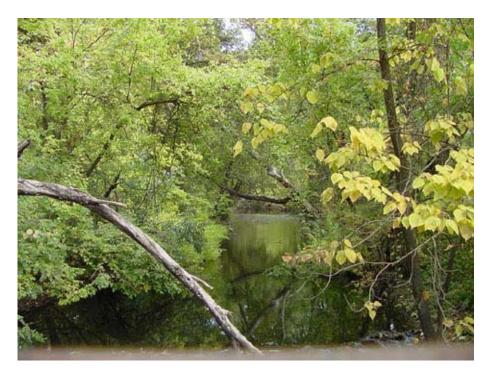
Upstream from the bridge near Forest Avenue, heavy growth along both banks.

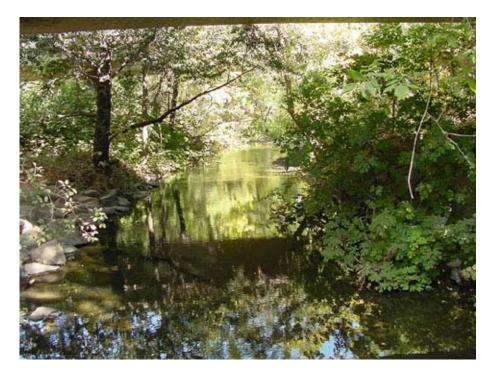
Upstream from Highway 99, heavy growth along both banks.

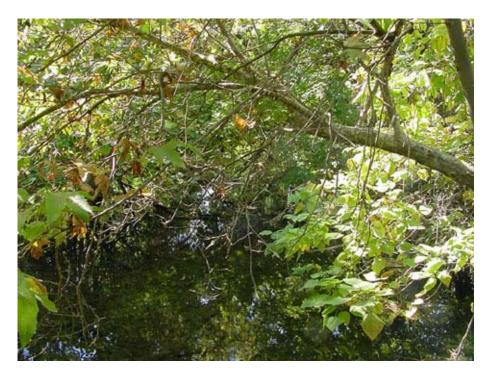
Downstream from Highway 99, dense vegetation in channel.

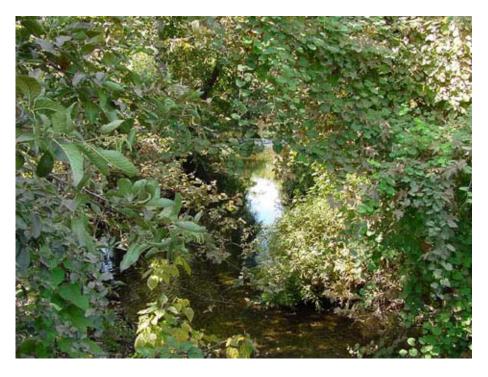
Downstream from Esplanade, heavy growth on both banks.

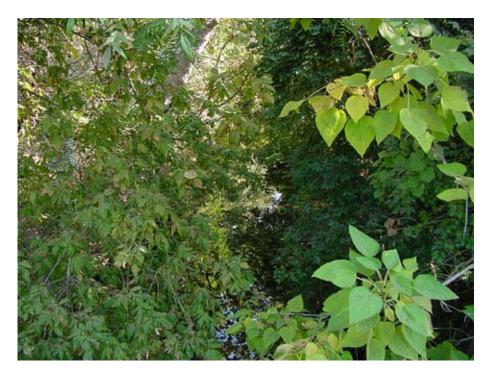
Upstream at Rose, heavy growth and dense vegetation in the channel and along both banks.

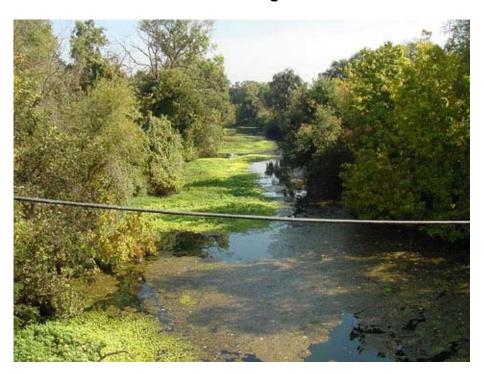
Upstream at confluence and River Road bridge.

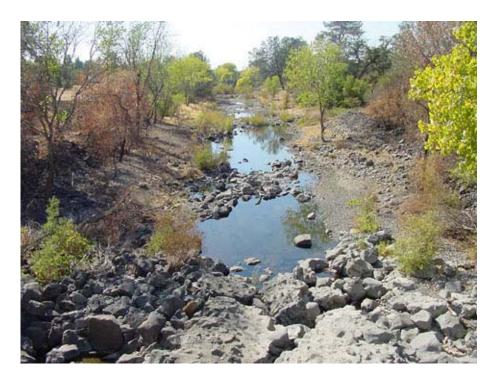
**Downstream from the Lindo Channel Diversion structure.**

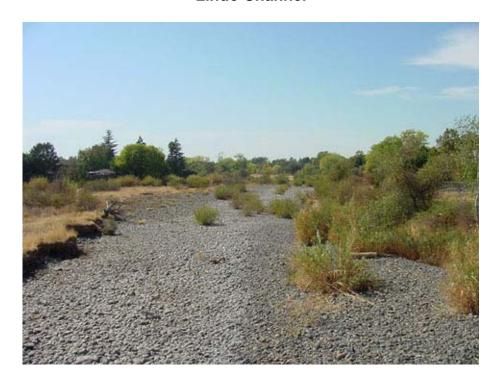
Upstream from the bike path bridge at the extension of Madrone Avenue.

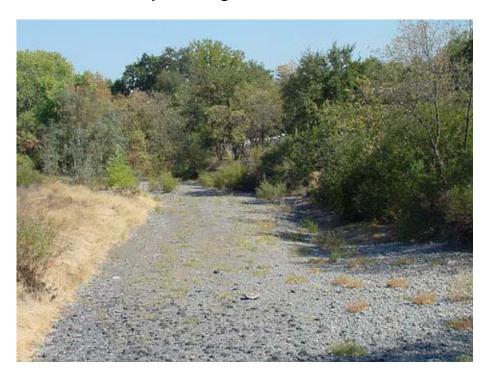
**Upstream at Mariposa.**

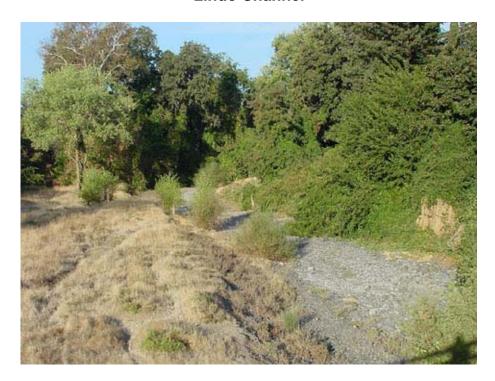
**Downstream from Esplanade.**

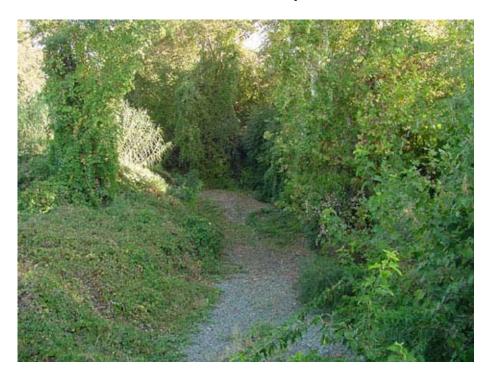
**Upstream from Nord Avenue, Highway 32.**

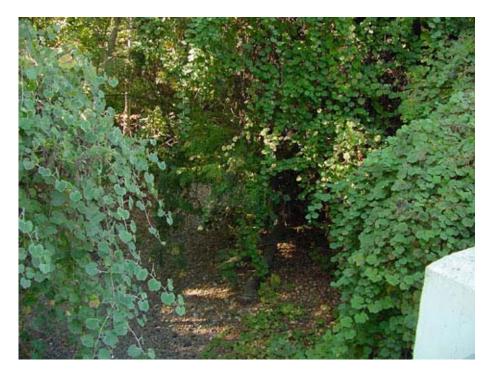
**Downstream from Oak Avenue.**

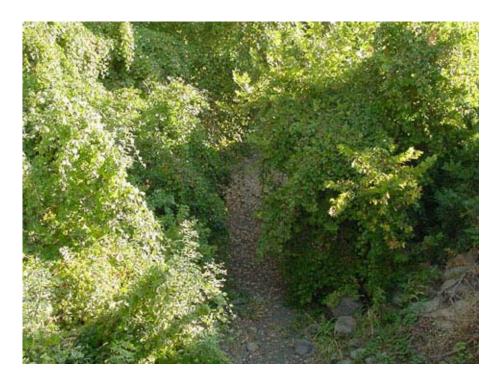
**Upstream from Grape Way.**

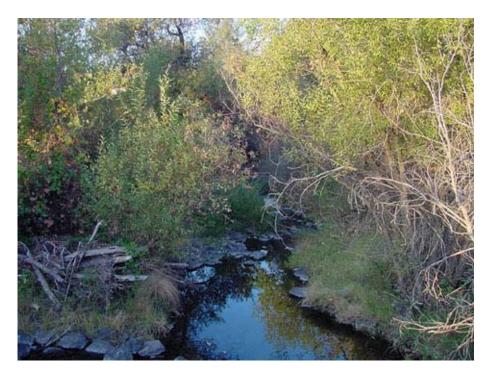
Downstream from the control structure, moderate growth in the channel.

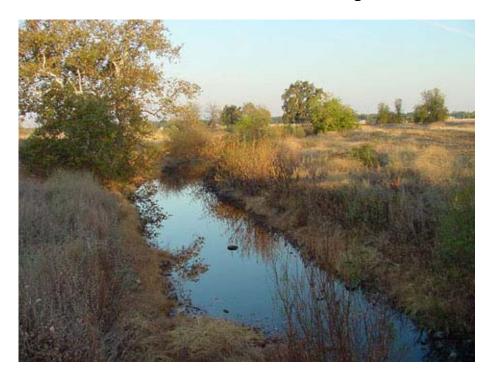
**Downstream from Bruce Road.**

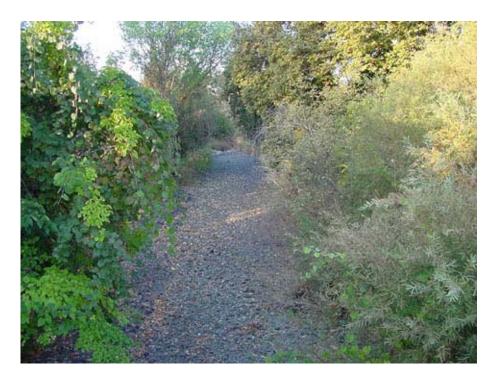
**Downstream from Forest Avenue.**

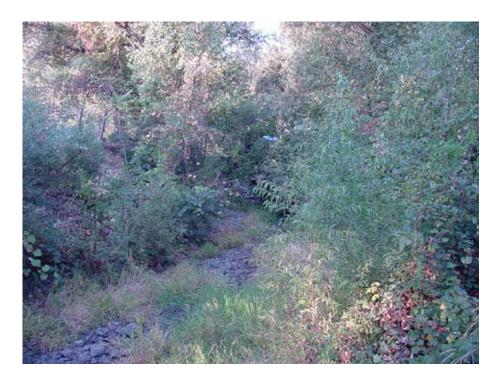
Downstream from Highway 99.

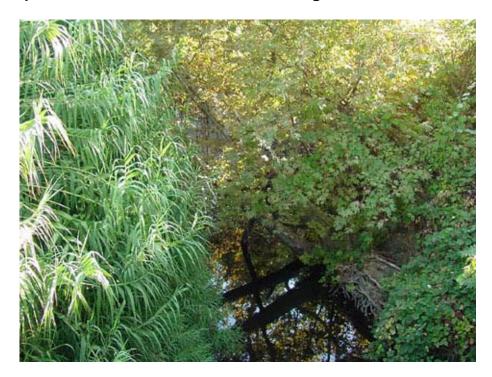
Upstream from Mill Street. Dense growth on both banks.

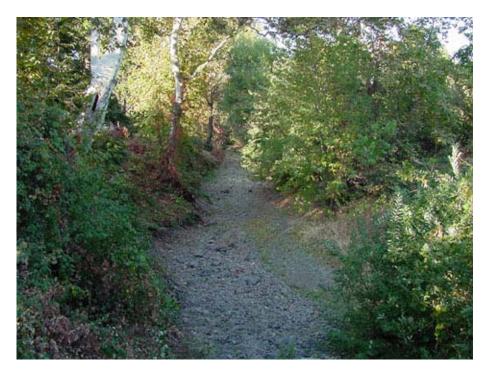
**Downstream from Olive Street.**

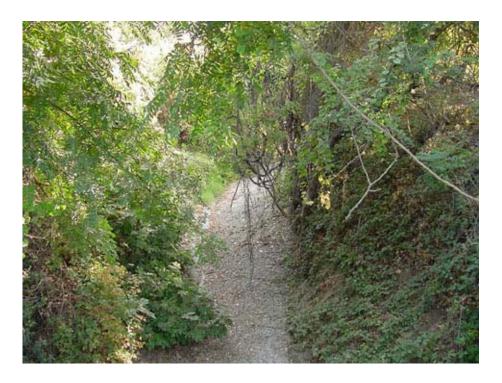
**Upstream from Crouch Avenue.**

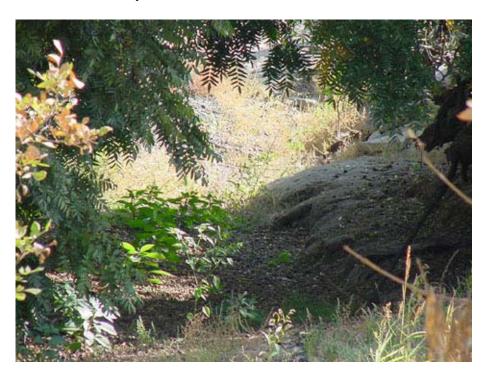
Upstream from Alberton Avenue. Scouring on left bank and in channel.

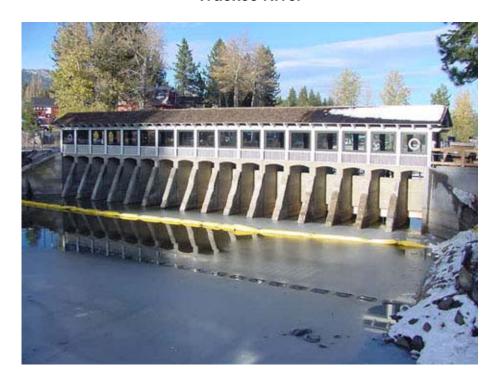
Upstream from Highway 89 toward the outlet structure.

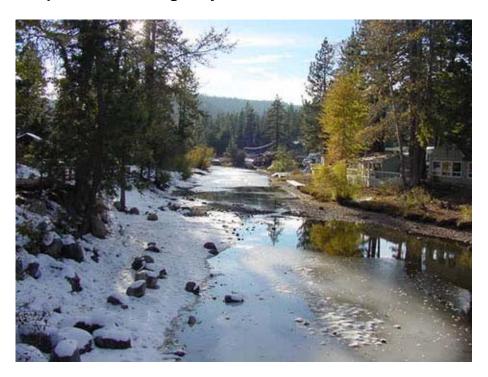
**Downstream from Highway 89.**

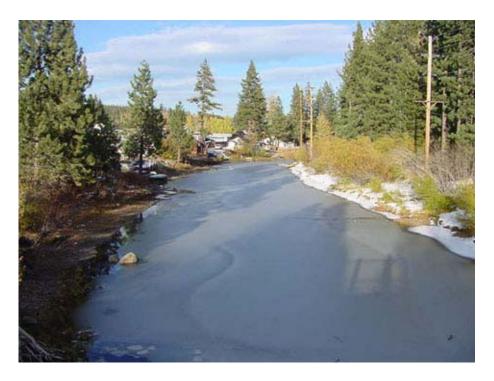
Upstream from the bike bridge, 1,000 feet downstream of the Lake Tahoe outlet structure.

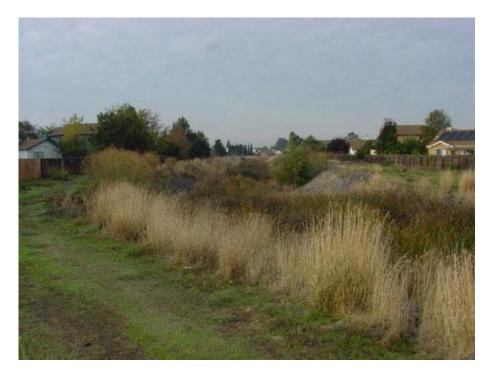
**Downstream from Bella Vista Drive.**

On October 29, 2004 an inspection was made of the McCoy Creek channel. The project channel begins at Prosperity Lane and extends downstream 1.22 miles to McCoy Creeks' confluence with Buffer Channel. The entire 1.22 miles were inspected. The views of the channel are primarily at road crossings. The photos on the following pages are typical of, but do not show all the growth in the channel. Vegetation is minimal and should not affect the flow. The patrol roads should be sterilized prior to flood season. The maintaining agency has an excellent maintenance program.

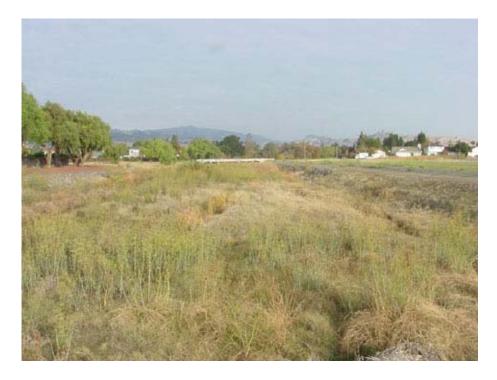
**Upstream from Cement Hill Road towards Gulf Drive.**

On October 29, 1004 an inspection was made of the Laurel Creek Channel. The project channel begins at Gulf Drive and extends downstream 2.78 miles to Laurel Creek's confluence with McCoy Creek. The entire 2.78 miles were inspected. The views of the channel are primarily at road crossings. The photos on the following pages are typical of, but do not show all the growth in the channel. Vegetation is minimal in the channel and does not affect the flow, however, new growth should be removed or sprayed. The maintaining agency has an excellent maintenance program.

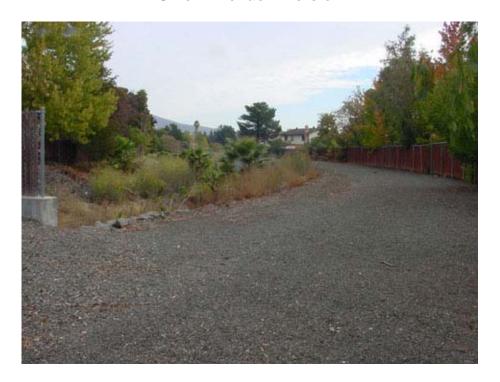
**Downstream from North Texas Street.**

On October 29, 2004, an inspection was made of the Union Avenue Diversion Channel. The project channel begins at North Texas Street and extends downstream 0.73 mile to Gulf Drive. The entire 0.73-mile was inspected. The views of the channel are primarily at road crossings. The photos on the following pages are typical of, but do not show all the growth in the channel. Vegetation is minimal in the channel and does not affect the flow, however, new growth should be removed or sprayed. The maintaining agency has an excellent maintenance program.

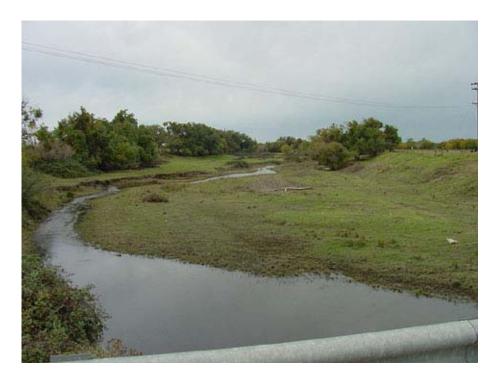
Downstream of the Bonner Road bridge.

On November 2, 2004 an inspection was made of Bear Creek. The project channel begins 2.0 miles upstream of the confluence with Burns Creek and extends downstream 21.0 miles to Bert Crane Road. Only 15 miles could be inspected due to limited access. The views of the channel are primarily at road crossings. The photos on the following pages are typical of, but do not show, all the growth in the channel. Moderate to heavy growth exists along both banks from the confluence with Burns Creek to approximately the Merced City limits. From Franklin Road to Dickerson Ferry Road, the channel and banks are overgrown to the extent that moderate flows could be adversely affected causing bank overflow. A clearing program should be implemented immediately. However, The California Department of Fish and Game has stopped the channel-clearing program. Both agencies are working to resolve the issues and continue channel maintenance.

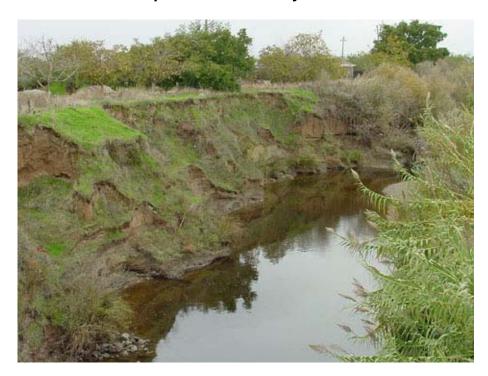
Bank washing away downstream from Kirby Road.

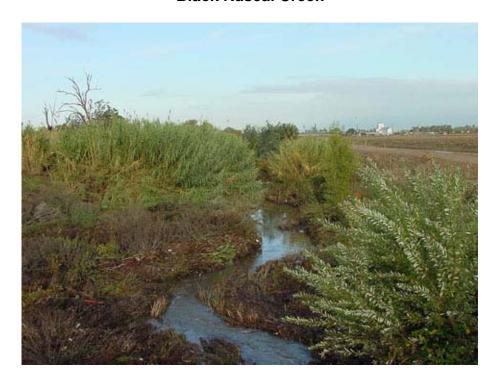
**Downstream from the Crocker Dam.**

On November 4, 2004 an inspection was made of Black Rascal Creek Channel. The project channel begins at Crocker Dam and extends downstream 6.5 miles to Black Rascal Creek's confluence with Bear Creek. Only 2.8 miles could be inspected. Views of the channel are primarily at road crossings. The photos on the following pages are typical of, but do not show all the growth in the channel. The wild growth should be cleared to allow proper design flow. However, the California Department of Fish and Game has stopped the channel-clearing program. Both agencies are working to resolve the issues and continue channel maintenance.

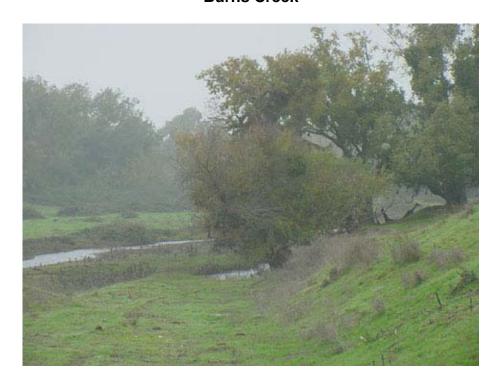
**Downstream from Bonner Road.**

On November 3, 2004 an inspection was made of Burns Creek. The project channel begins 2.0 miles upstream of Burns Creek's confluence with Bear Creek and extends 2.0 miles downstream to the confluence. Only 1.0 mile of channel could be inspected due to inaccessibility. The photos on the following pages are typical of, but do not show all the growth in the channel. There appears to have been little maintenance performed in the past years. Merced County should mechanically clear and spray the channel. However, the California Department of Fish and Game has stopped the channel-clearing program. Both agencies are working to resolve the issues and continue channel maintenance.

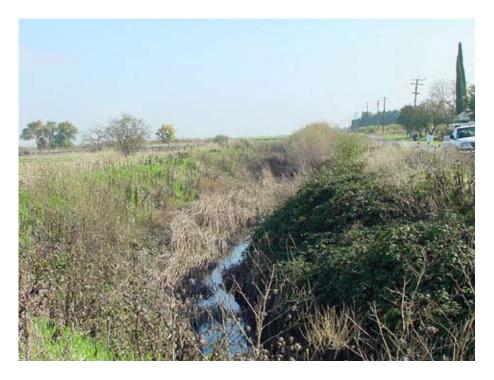
**Upstream from Childs Avenue.**

On November 4, 2004 an inspection was made of Miles Creek channel. The project channel begins 1.5 miles upstream of Childs Avenue and extends downstream for 12.0 miles to Highway 59. Only 5.6 miles of the channel could be inspected due to limited access. The views of the channel are primarily at road crossings. The photos on the following pages are typical of, but do not show all the growth in the channel. There is intermittent heavy brush growth with garbage backed up against the growth throughout the system. The channel is constricted by trees and brush from Riley Road to the Miles Creek Dam and should be cleared before next flood season. However, the California Department of Fish and Game has stopped the channel-clearing program. Both agencies are working to resolve the issues and continue channel maintenance.

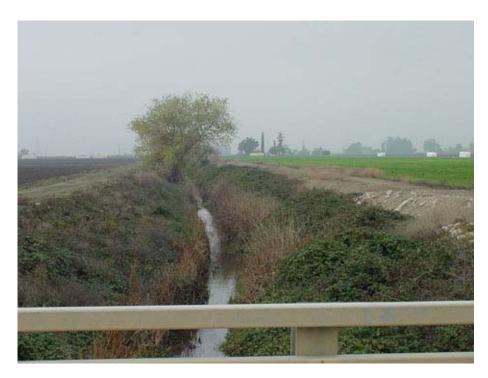
Downstream from Arboleda Drive. Notice the blackberrys on the right bank.

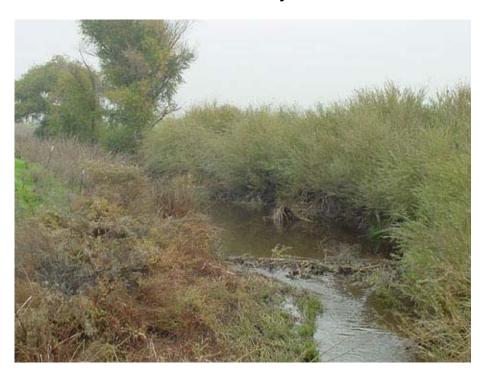
Upstream from Highway 59.
The channel is overgrown with wild growth.

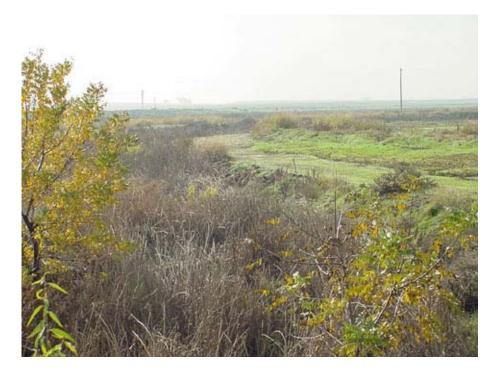
**Downstream from Cunningham Road.**

On November 5, 2004 an inspection was made of Owens Creek channel. The project channel begins at Cunningham Road and extends downstream for 2.0 miles to Owens Creek Diversion channel. Only 1.2 miles of the channel could be inspected due to limited access. Major tule growth was found in the channel. Tules should be sprayed to control growth. However, the California Department of Fish and Game has stopped the channel-clearing program. Both agencies are working to resolve the issues and continue channel maintenance.

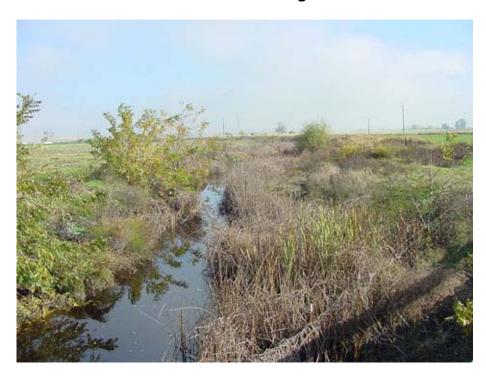
Upstream from Childs Avenue.
Note the tule growth.

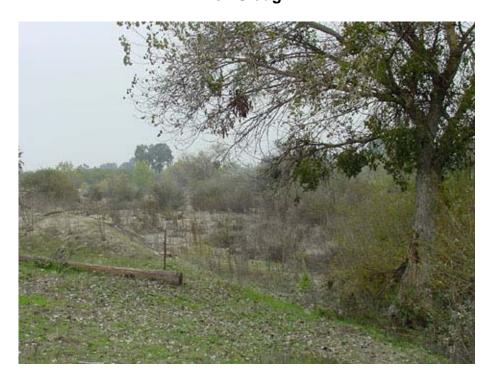
**Downstream from Ash Slough bifurcation structure.**

On November 16, 2004 an inspection was made Ash Slough channel. The project channel begins at the Ash and Berenda Slough Bifurcation Structure and extends downstream for 19.0 miles to Avenue 22. Only 10.3 miles could be inspected due to limited access. The views of the channel are primarily at road crossings. The photos on the following pages are typical of, but do not show all the growth in the channel. There are some willows and bamboo on the banks, but the channel appears to be in satisfactory condition. There has been no apparent maintenance in recent years. The new growth needs to be removed and sprayed.

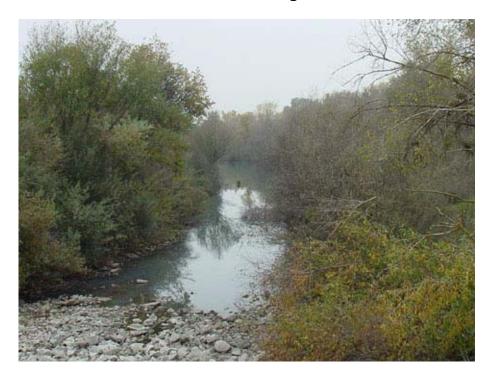
Downstream from the Berenda Slough bifurcation structure.

On November 17, 2004 an inspection was made of Berenda Slough channel. The project channel begins at the Ash and Berenda Slough Bifurcation Structure and extends downstream for 18.5 miles. Only 13.0 miles could be inspected due to limited access. The views of the channel are primarily at road crossings. The photos on the following pages are typical of, but do not show all the growth in the channel. Dense wild growth is chocking the channel 200 yards from the structure. The channel has areas of willow and bamboo growth that should be cleared. There appears to have been little to no maintenance performed in the past several years. The wild growth should be cleared to allow proper design flow.

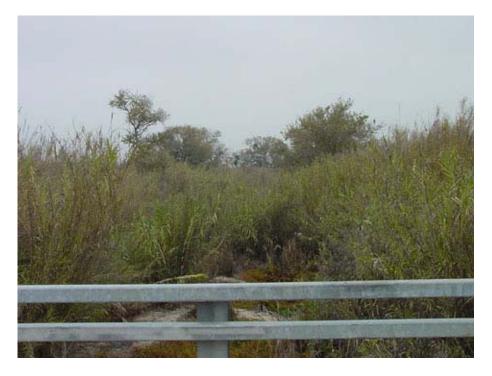
Upstream from Avenue 20. Trees and wild growth in channel.

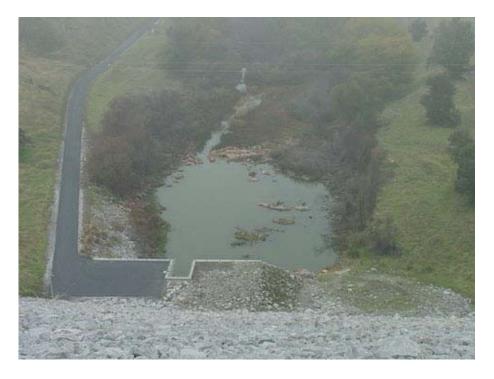
Downstream from Buchanan Dam.

On November 18, 2004 an inspection was made of the Chowchilla River channel. The project channel begins at Buchanan Dam and extends downstream for 28.5 miles to Schultz Road. Only 18.4 miles could be inspected due to limited access. The views of the channel are primarily at road crossings. The photos on the following pages are typical of, but do not show all the growth in the channel. The channel east of Highway 99 is through pastureland with trees immediately upstream of Road 19 (White Rock Road) posing the only constriction. From Highway 99 downstream there are areas of heavy brush and tree growth that should be cleared. Upstream from Avenue 26, wild growth has been partially removed about 100 feet away from bridge. Downstream from Avenue 26, the channel is cleared by livestock grazing. Where there is livestock grazing, fences have been put up across the channel and other obstructions placed in the channel and along the banks. These areas should be cleared to allow the water to flow without collecting debris. Down from Avenue 25, garbage needs to be removed from the channel. The wild growth should be cleared to allow proper design flow.

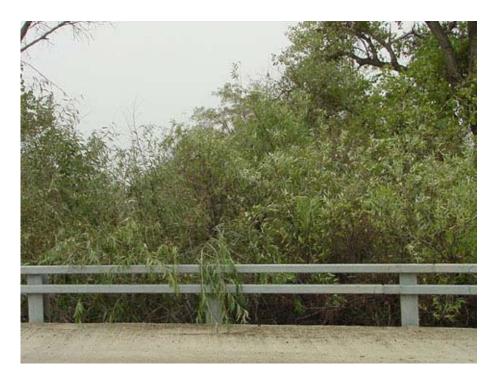
Downstream Road 13 (Vista Avenue).

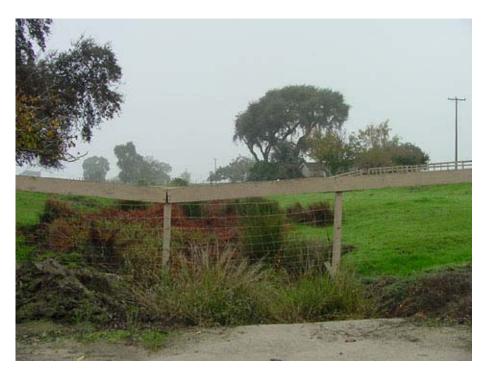
Upstream Road 11. Fencing across the channel.

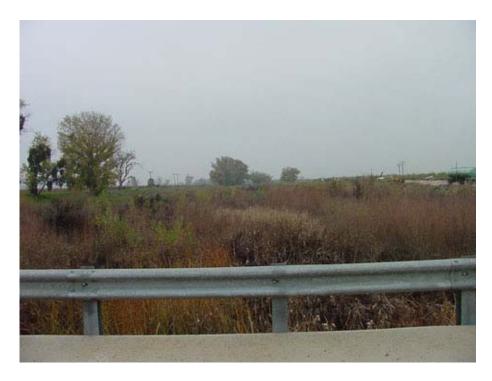
Downstream from Road 20.
Bamboo and small trees growing in the channel.

On November 18, 2004 an inspection was made of the Fresno River channel. The project channel begins at Hidden Dam and extends downstream for 13.0 miles to Road 18½. Only 9.0 miles could be inspected due to limited access. The views of the channel are primarily at road crossings. The photos on the following pages are typical of, but do not show all the growth in the channel. There is some small willow growth in the channel but the maintaining agency does a good job of discing it annually so that the growth is kept under control. The District has an excellent maintenance program.

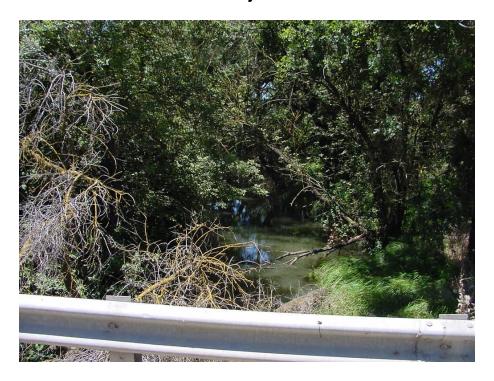
Downstream from Van Allen Road, dense vegetation in channel.

On November 29, 2004 an inspection was made of the North Littlejohn Creek channel. The project channel begins at its bifurcation with South Littlejohn Creek and extends downstream for 18.0 miles to North Littlejohn Creek's confluence with French Camp Slough. Only about 12.5 miles could be inspected due to limited access. The views of the channel are primarily at road crossings. The photos on the following pages are typical of, but do not show all the growth in the channel. There are areas, especially at the upper end, that have moderate tree growth in and around the channel. Wild growth in channel should be cleared.
